Case study

# **SILSBOND PRETREATMENT AS A REPLACEMENT OF ZINC PHOSPHATING FOR GENERAL INDUSTRIES**

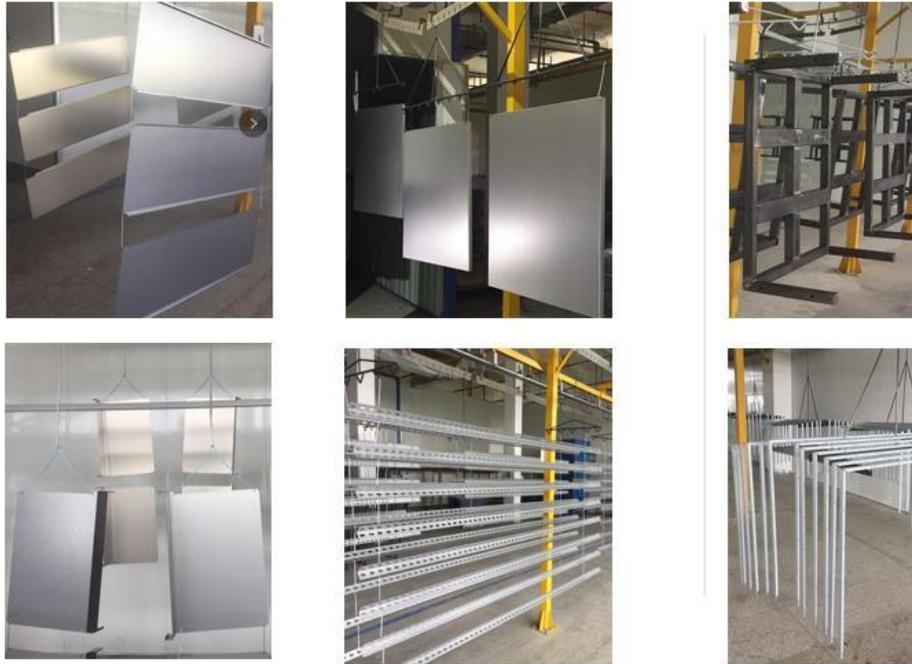
Figure 1. Metal workpieces to be painted

- **Client:** Shanghai Fufu Machinery Technology Co., Ltd. (China). It is a manufacturer for making metal parts for general industries. It makes workpieces with different geometries and various types of metals. They include metal shelves, bars, bottom plates, TV back panels, frames, etc.(Figure 1). An 8-step zinc phosphate pretreatment had been successfully used for years to enhance paint adhesion of the workpieces.

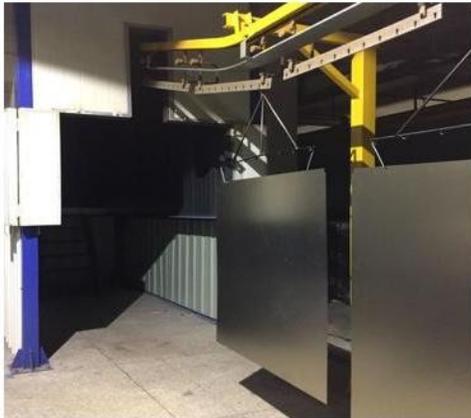
Figure 2. Elimination of flash rust problem by using SILSBOND 01

Nano-ceramic pretreated steel panels, with yellow-brownish appearance

◦ **Outcomes:** SILSBOND 01 pretreatment provides excellent corrosion protection for steel parts. In addition, the use of SILSOND 01 not only helps the customer replace the zinc phosphate pretreatment but also eliminates the flash rust issue caused by using nano-ceramic pretreatment. (Figure 2). A 1000-hr salt spray test (SST) result for the powder painted cold rolled steel test panels shows no delamination in the scribes, indicating SILSBOND 01 offers excellent paint adhesion and corrosion resistance during salty and humid environment.

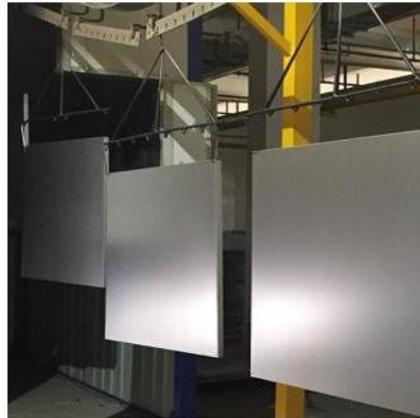
SILSBOND 01 pretreated steel panels with original metal appearance
